STUDY OF THE TECHNOLOGY OF STRENGTHENING REINFORCED CONCRETE COLUMNS BY EXTERNAL REINFORCEMENT

Molodid O. S.

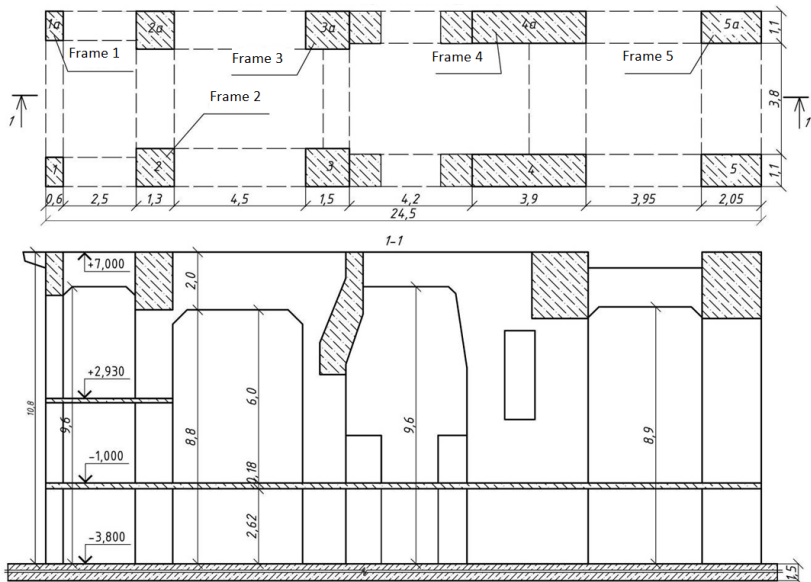
Fig. 1. Plan and cross-section of the superstructure block of the turbine-generator set foundation

As a construction, the foundation is a monolith frame system consisting of five interconnected frames and 8 ribs, and a common base slab. The foundation dimensions of in the plan are 24.5 x 6 m (fig. 1). The height of the foundation is 10.8 m. The top of the maintenance platform is +7.0 m, the top of the base slab – 3.8 m.

Each separate frame of the foundation, with the height of 10.8 m, is formed of two vertical elements (columns or piers) divided in two, in some places in three, tiers by floor slabs 200 mm in thickness, and united by a beam in the upper part into a common construction. The cross-section of the vertical elements varies from 1.0 x 0.6 to 1.1 x 3.9 m.

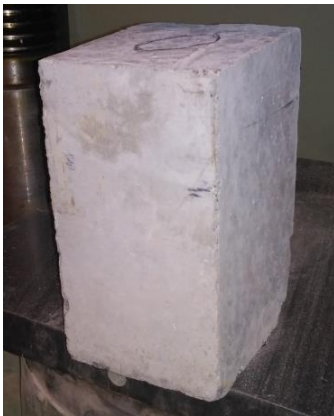
Fig. 2. Overall view of a non-reinforced sample

- series 1 – no actions were performed with the control samples (no reinforcement was added) (fig. 2);
- series 2 – the samples' angles were rounded, their surface was pre-coated, a coat of glue was applied, in which carbon fiber was sunk, and an extra coat of glue was applied on top of the fiber;
- series 3 – the samples' angles were not rounded, their surface was pre-coated, a coat of glue was applied, in which carbon fiber was sunk, and an extra coat of glue was applied on top of the fiber;
- series 4 – the samples' angles were rounded, a coat of glue was applied, in which carbon fiber was sunk, and an extra coat of glue was applied on top of the fiber;
- series 5 – the samples' angles were rounded, a coat of glue was applied, in which the carbon fiber was sunk,
- series 6 – the samples' angles were rounded, carbon fiber impregnated with glue was glued to the surface.

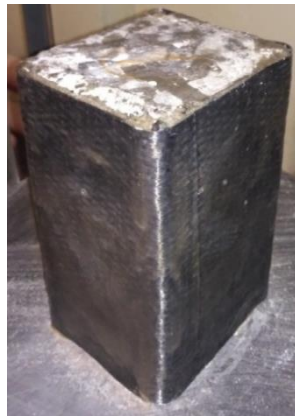
Fig. 3. Overall view of a reinforced sample

The samples were reinforced by gluing unidirectional carbon fibers to all their lateral surfaces by wrapping.

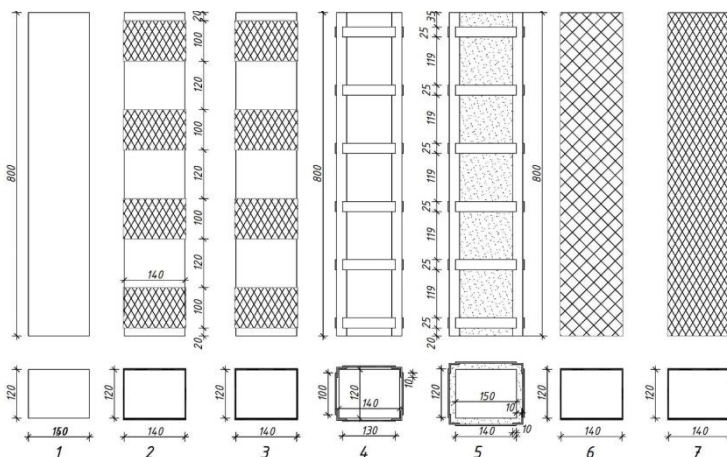
Fig. 4. Patterns of sample strengthening in test series

Seven series of experimental tests were planned (fig. 4, 5):

- series 1 – no actions were performed with the control samples (no reinforcement was added) (
- series 2 – the samples' angles were rounded, their surface was pre-coated, a coat of glue was applied, in which carbon fiber strips was sunk, and an extra coat of glue was applied on top of the fiber (the fiber was glued with the materials manufactured by COMPOSIT LLC);
- series 3 – the samples' angles were rounded, their surface was pre-coated, a coat of glue was applied, in which carbon fiber strips was sunk, and an extra coat of glue was applied on top of the fiber (the fiber was glued with the materials of MAPEI™);
- series 4 – metal casing with pre-stressed plates;
- series 5 – metal casing at the distance of 10 mm along the perimeter from the column with further application of sprayed-on plaster, while the cavity pockets between the column angles and casing angles were filled;

– series 6 – the samples' angles were rounded, their surface was pre-coated, a coat of glue was applied, in which polyethylene-terephthalate fiber was sunk, covering the whole surface, and an extra coat of glue was applied on top of the fiber (the fiber was glued with the materials manufactured by COMPOSIT LLC);

– series 7 – the samples' angles were rounded, their surface was pre-coated, a coat of glue was applied, in which the carbon fiber was sunk, covering the whole surface, and an extra coat of glue was applied on top of the fiber (the fiber was glued with the materials manufactured by COMPOSIT LLC).

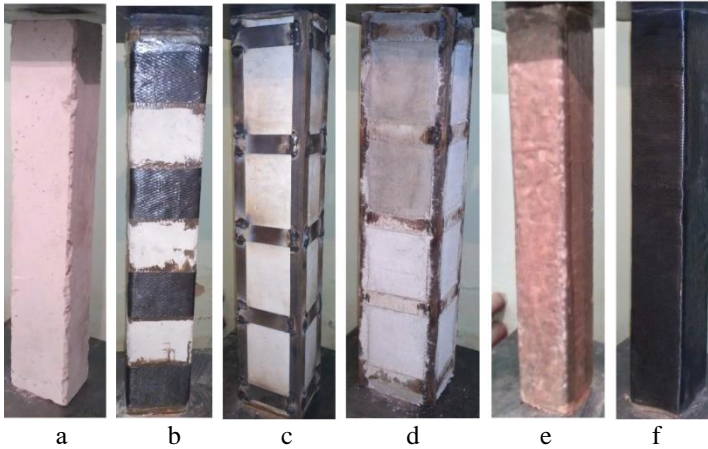
**Fig. 5. General view of the tested columns:**

a – not strengthened (series 1); b – strengthened with carbon fiber strips (series 2, 3); c – strengthened with metal casing with pre-stressed plates (series 4); d – metal casing at a distance from the column with the cavity pocket filled with plaster (series 5); e – solid strengthening with polyethylene-terephthalate fabric (series 6); f – solid strengthening with carbon fabric (series 7)

– The analysis of the experimental test results demonstrated that the highest bearing strength was reached on the samples of columns with full strengthening with carbon fibers (54.4 tons) (test series 7). The compression strength of such samples is 97.9 % higher than that of the control samples (test series 1). The strength increase by 52.5 % and 54.5 % as compared with the control samples was reached in the samples with metal casing and plaster and samples strengthened with strips of carbon fiber glued with the materials manufactured by COMPOSIT LLC (test series 5 and 2). Strengthening columns using the classical technology (test series 4) increased its compression strength by 37.6 % as compared with the control samples.

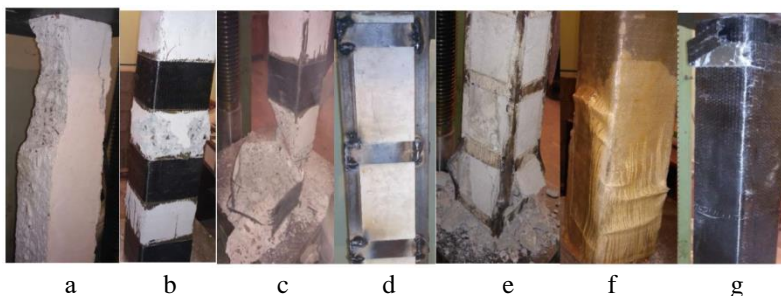
Fig. 6. General view of the columns after the tests:

- a – not strengthened (series 1); b – strengthened with carbon fiber strips (series 2); c – strengthened with metal casing with pre-stressed plates (series 3);
 d – strengthened with metal casing with pre-stressed plates (series 4);
 e – metal casing at a distance from the column with the cavity pocket filled with plaster (series 5); f – solid strengthening with polyethylene-terephthalate fabric (series 6); g – solid strengthening with carbon fabric (series 7)

Fracture of the tested column samples is displayed at fig. 6

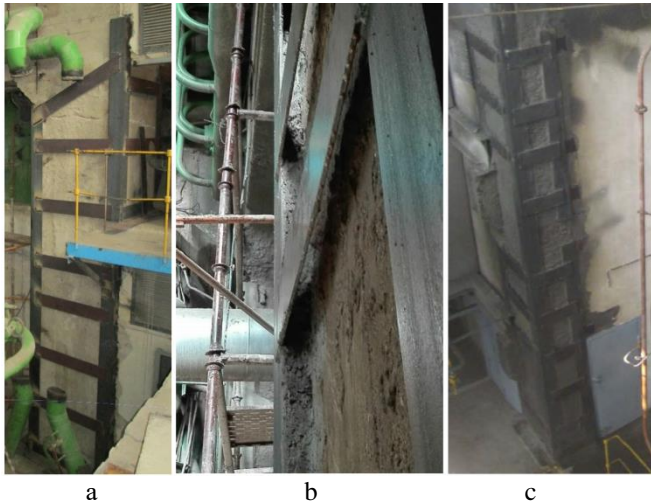
Fig. 7. Photos demonstrating the process of column strengthening:
a – fitting of metal casings; b – filling cavity pockets between the column angles and casing angles with sprayed-on plaster; c – strengthened column

The comprehensive process of strengthening the support structures of the frames consisted of a number of simple processes: surface preparation, assembly of metal casing (fig. 7, a); application of Consolid-1 and Consolid-2 composite materials manufactured by COMPOSIT LLC; application of sprayed-on plaster (fig. 7, b).

corrosive protection of the welding connections; applying one layer of Consolid-1 composite material on the surface (fig. 7, c)⁶.
